Investigation of the Performance of the New Orleans Flood Protection Systems in Hurricane Katrina on August 29, 2005

Volume I: Main Text and Executive Summary

**Final Report
July 31, 2006**

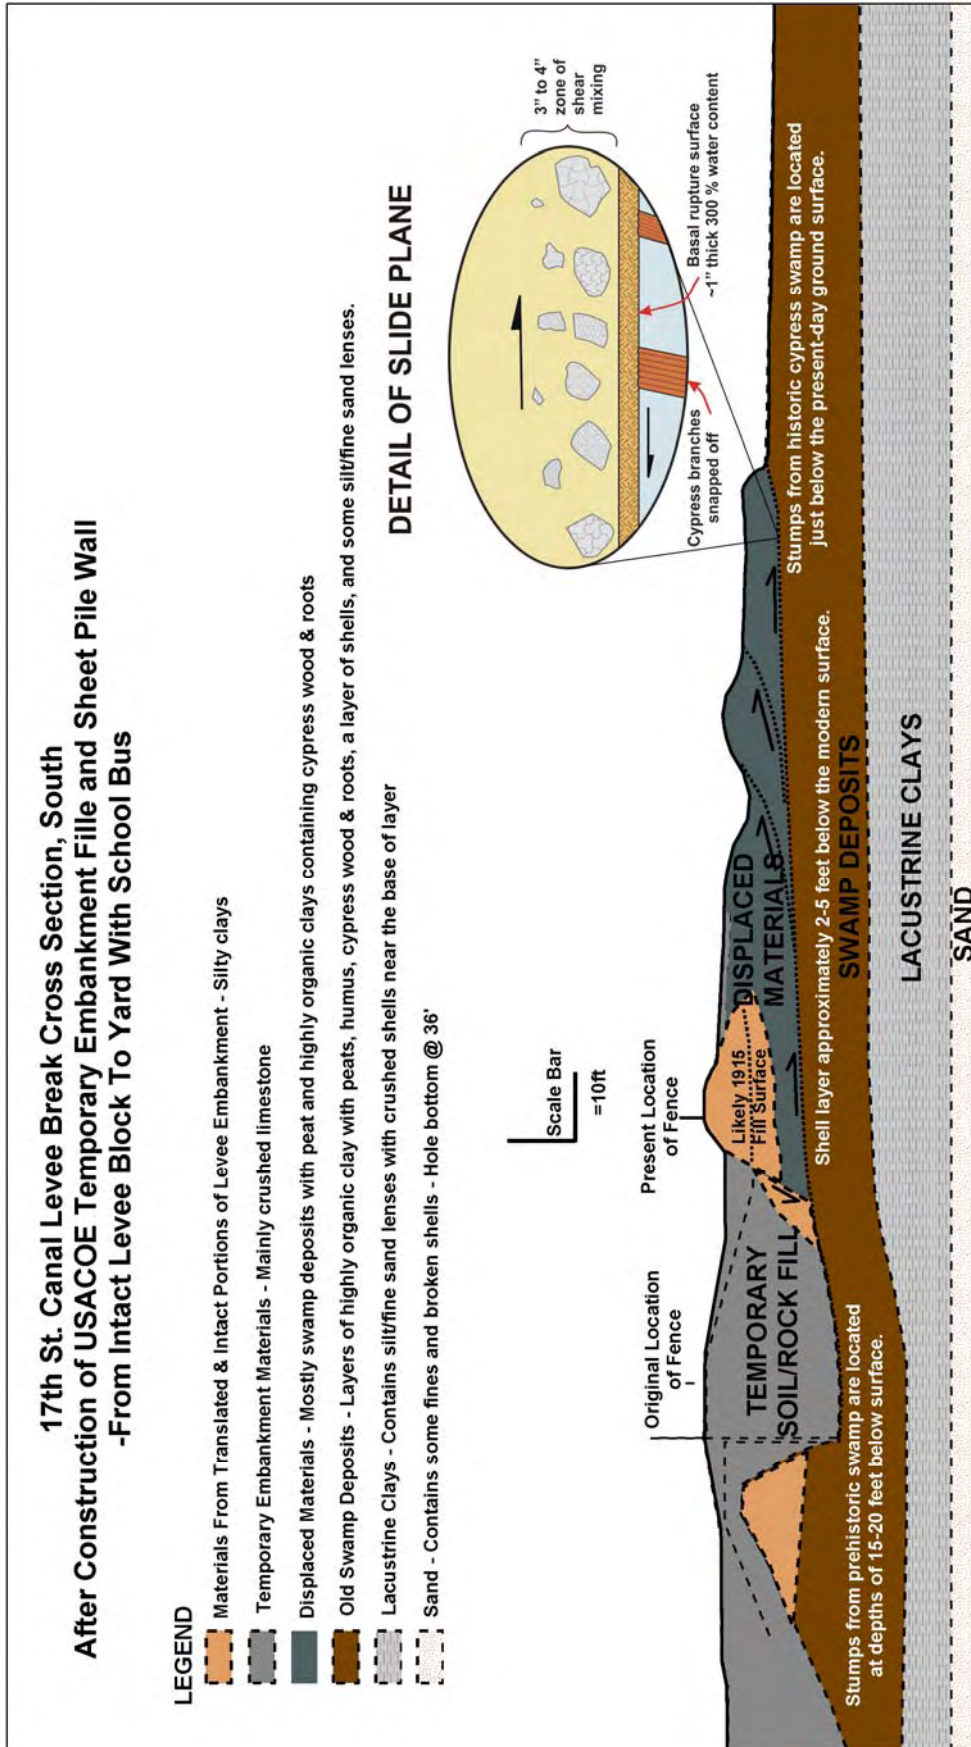
Figure 3.18: West-to-east geologic cross section through the 17th Street Canal failure approximately 60 feet north of the northern curb of Spencer Avenue, close to the yellow school bus. A detailed sketch of the basal rupture surface is sketched above right. The slip surface was about one inch thick with an extremely high moisture content (watery ooze). A zone of brecciation 3 to 4 inches thick was above this. Numerous pieces of cypress wood, up to 2 inches diameter, were sheared off along the basal rupture surface.

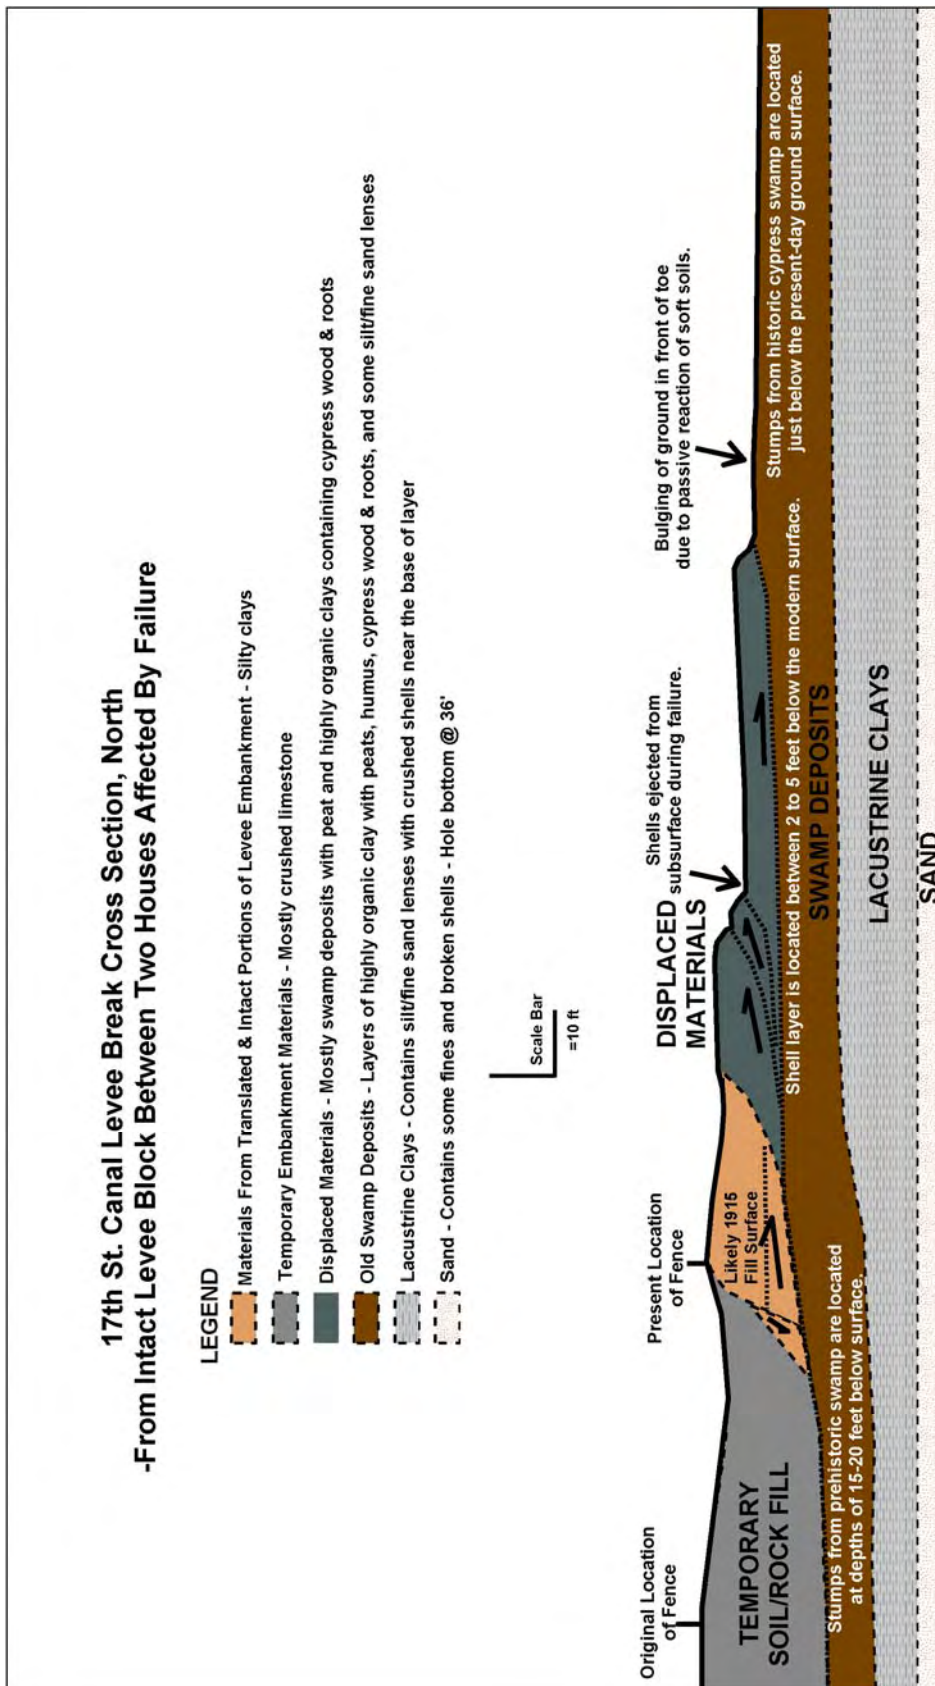
Figure 3.19: West-to-east geologic cross section through the 17th Street Canal failure approximately 140 feet north of the northern curb of Spencer Avenue, just north of the first surviving home next to the canal. Large quantities of bivalve shells were extruded by high water pressure along the regressing toe thrusts (shown in Figure 3.20). Note the slight back rotation of the distal thrust block.

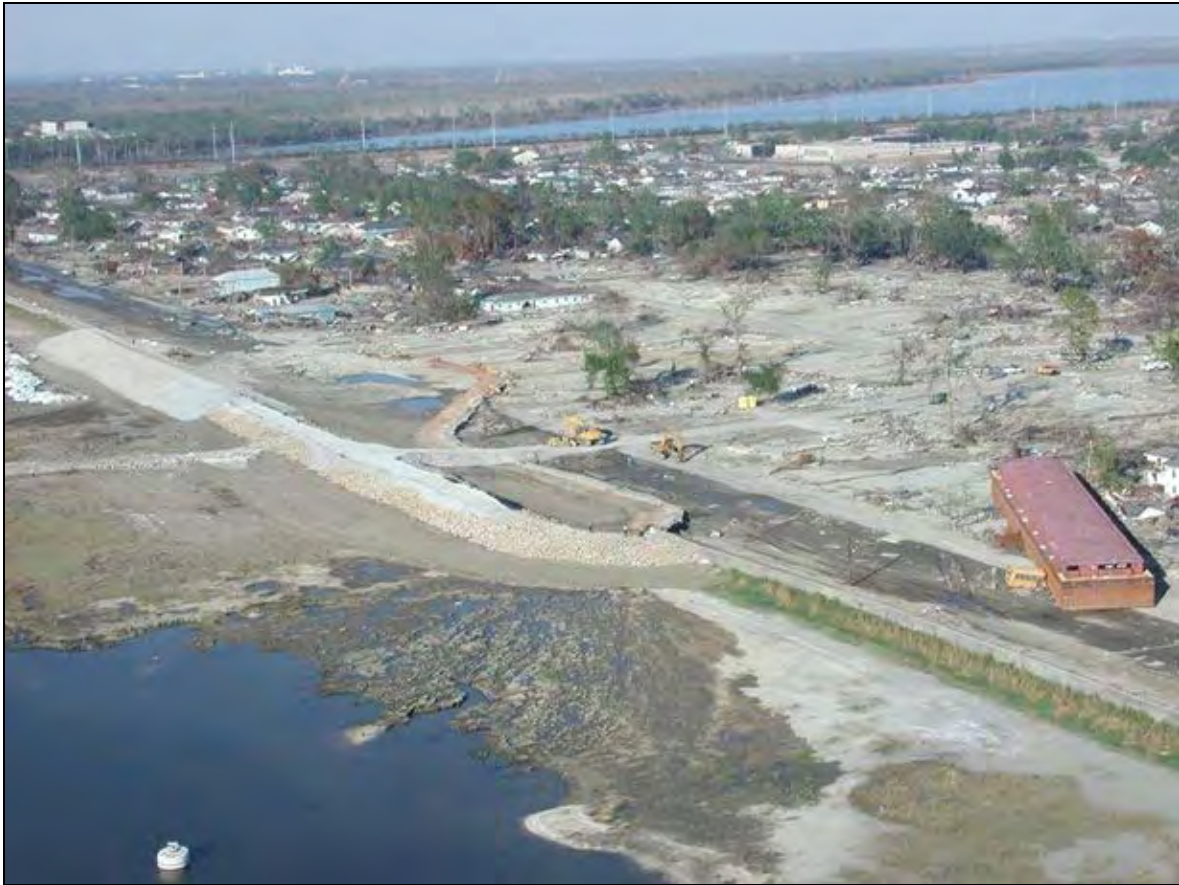
Figure 4.30: Seepage crevasse splay exposed on the water side of the east levee of the IHNC breach, likely from back-drainage of the flood-inundated area of the Lower Ninth Ward, after Hurricanes Katrina and Rita. This same section of the IHNC levee failed in 1965 during Hurricane Betsy. Seepage crevasse splays tend to occur where high permeability materials daylight, or come into proximity of the existing ground surface. They are easily recognized by anomalous seepage and the birdfoot pattern of the splays, which are often filled with soils displaced by seepage and hydraulic piping. (photo from U.S. Army Corps of Engineers).

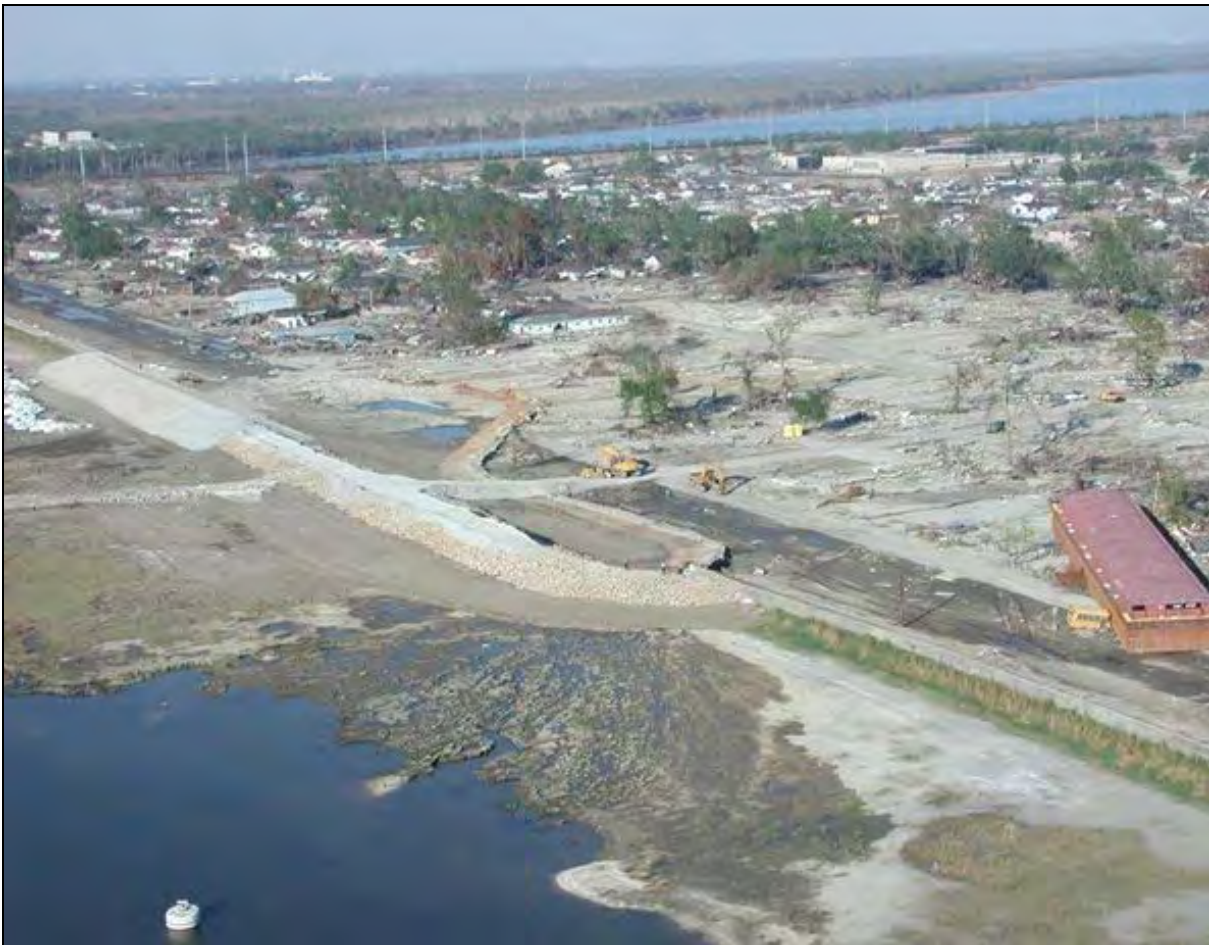
Figure 6.45: Aerial view of the south breach at the east bank of the IHNC (at the west end of the Ninth Ward), showing the crevasse splay generated by reverse drainage flow.

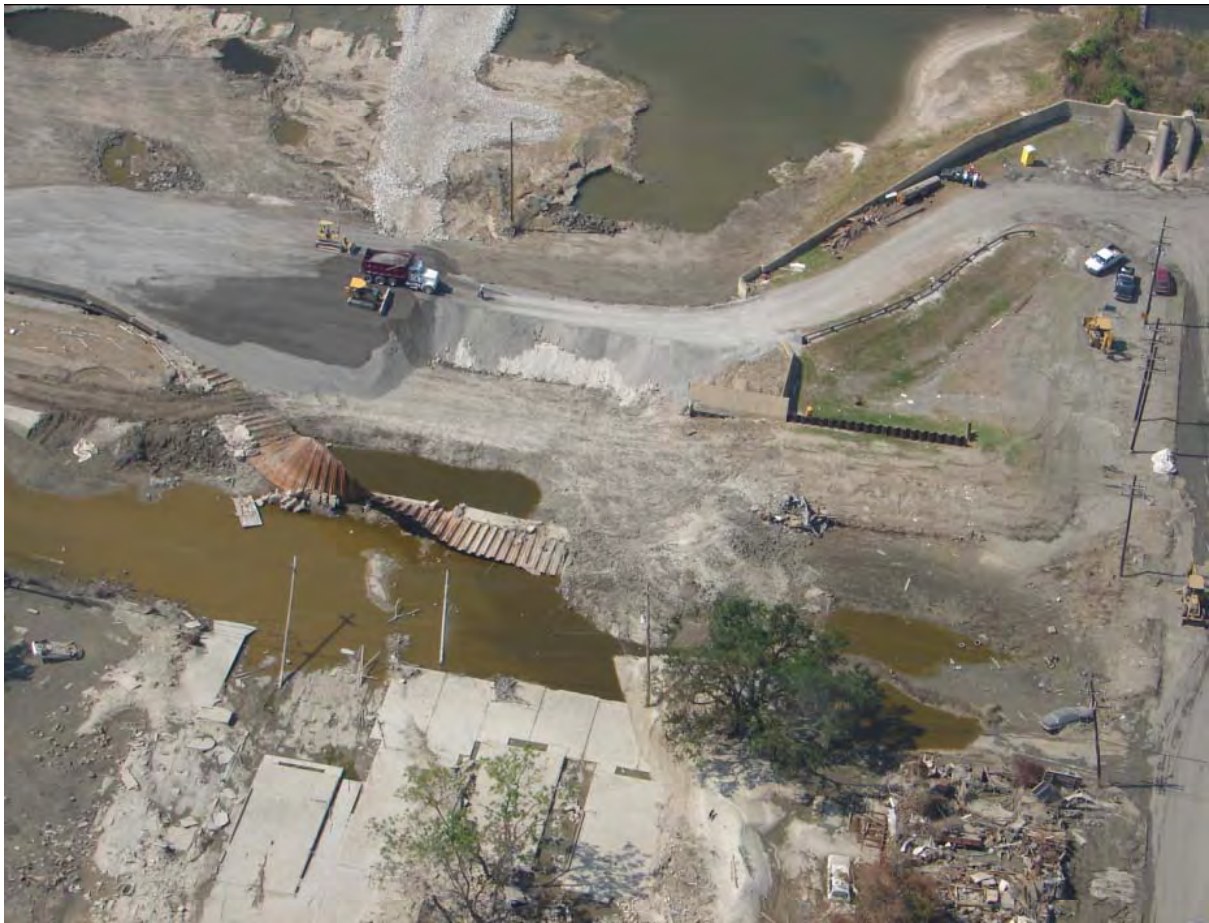
Figure 6.46: Aerial view of the partially repaired north breach on the east bank of the IHNC at the west end of the Lower Ninth Ward.

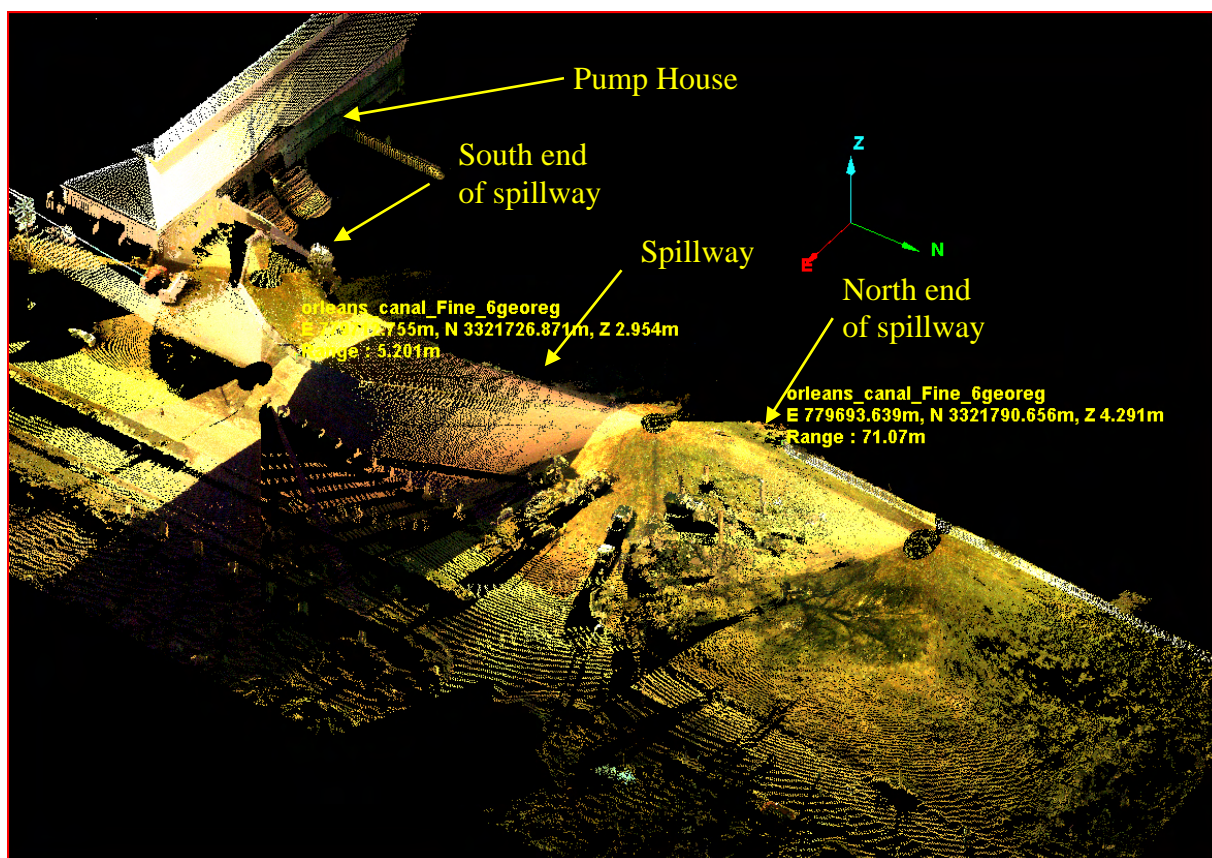
Figure 8.21: Oblique view of LIDAR survey of the southern end of the Orleans Canal, showing the “gap” on the east side where the levee and floodwall that should have sealed the end are omitted, and a “spillway” replaces them.

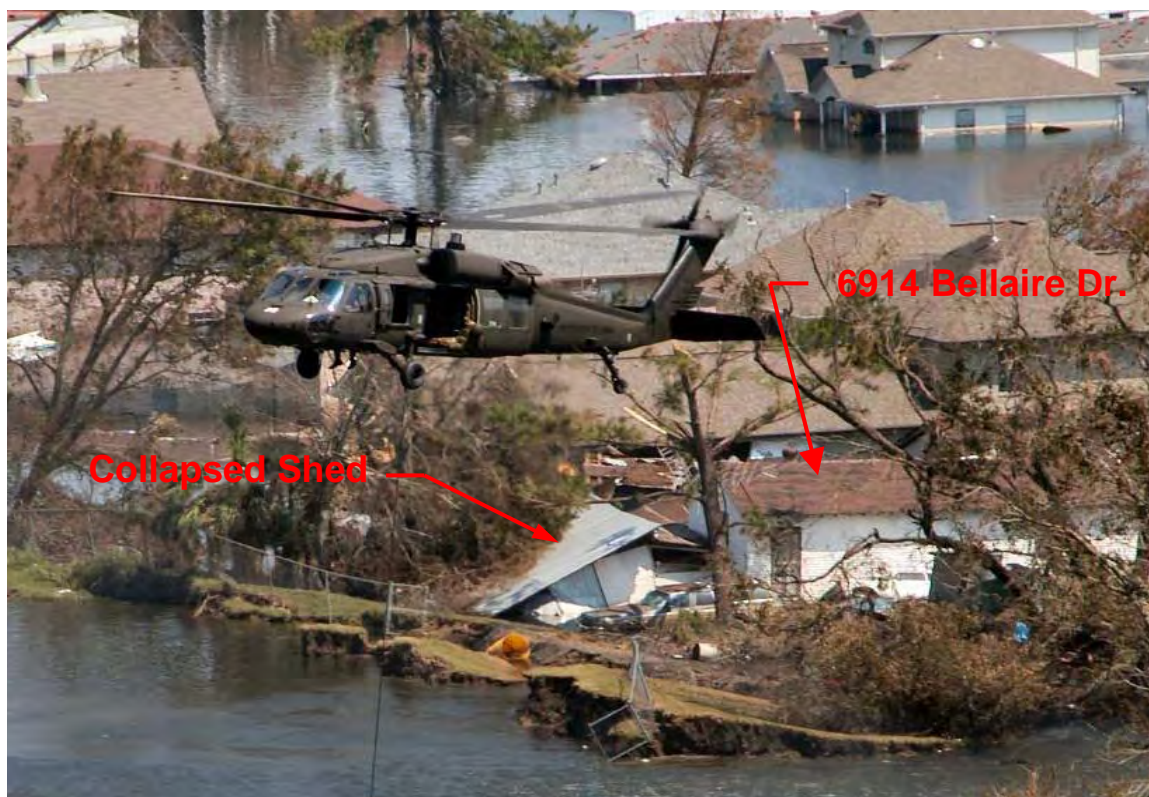
Figure 8.30: Side view of the collapsed shed pushed into the house at 6914 Bellaire Drive as illustrated in the cross-section of Figure 8.27.

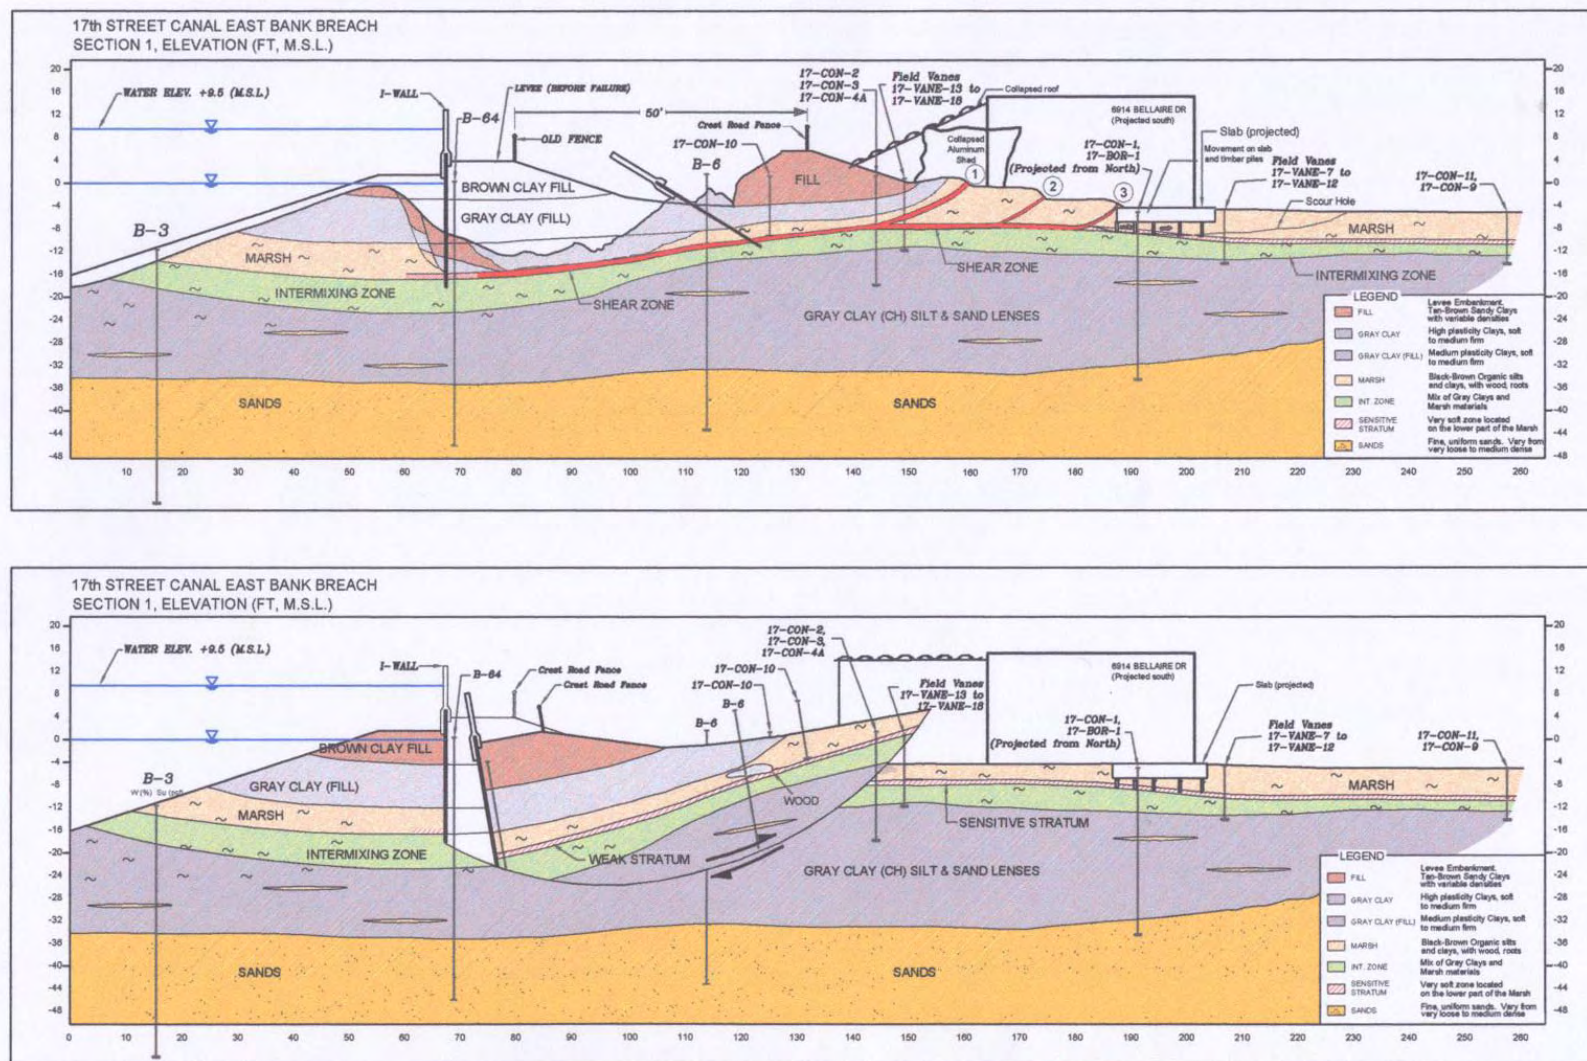
Figure 8.69: Comparison between deep rotational failure through the soft gray clay (CH) and translational failure along the sensitive clay layer within the marsh deposits as actually observed.

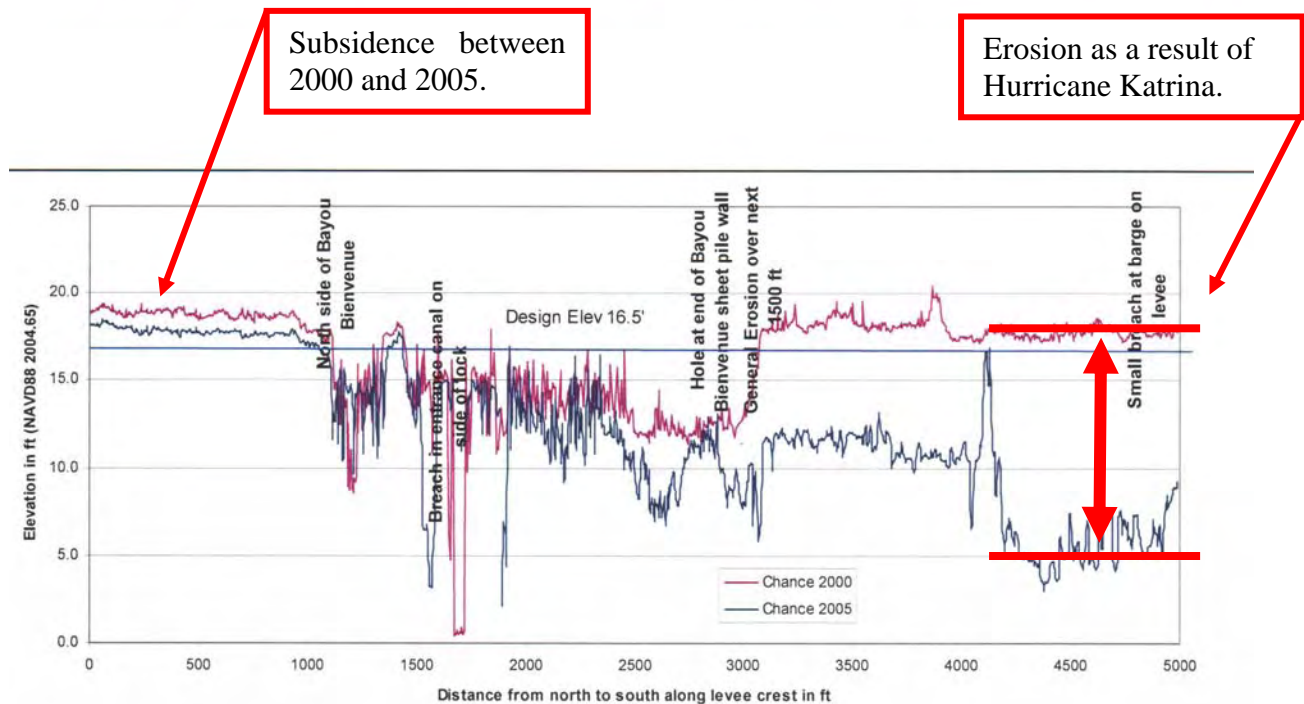
Figure 10.37: This is a comparison of two LiDAR surveys of the MRGO levee system at the Bayou Bienvenue control structure, near the intersection of the GIWW at the northeast corner of St. Bernard Parish. Effects of subsidence can be clearly seen in the elevation differences on the north side of the control structure and the control structure itself between 2000 and immediately following Hurricane Katrina in 2005. The levee on the north side of the Bayou Bienvenue control structure was largely undamaged. The levee on the south side of the control structure was catastrophically damaged. The magnitude of the erosion has been highlighted and white “splashes” of displaced levee materials can be seen in the aerial photograph (USACE 2006).

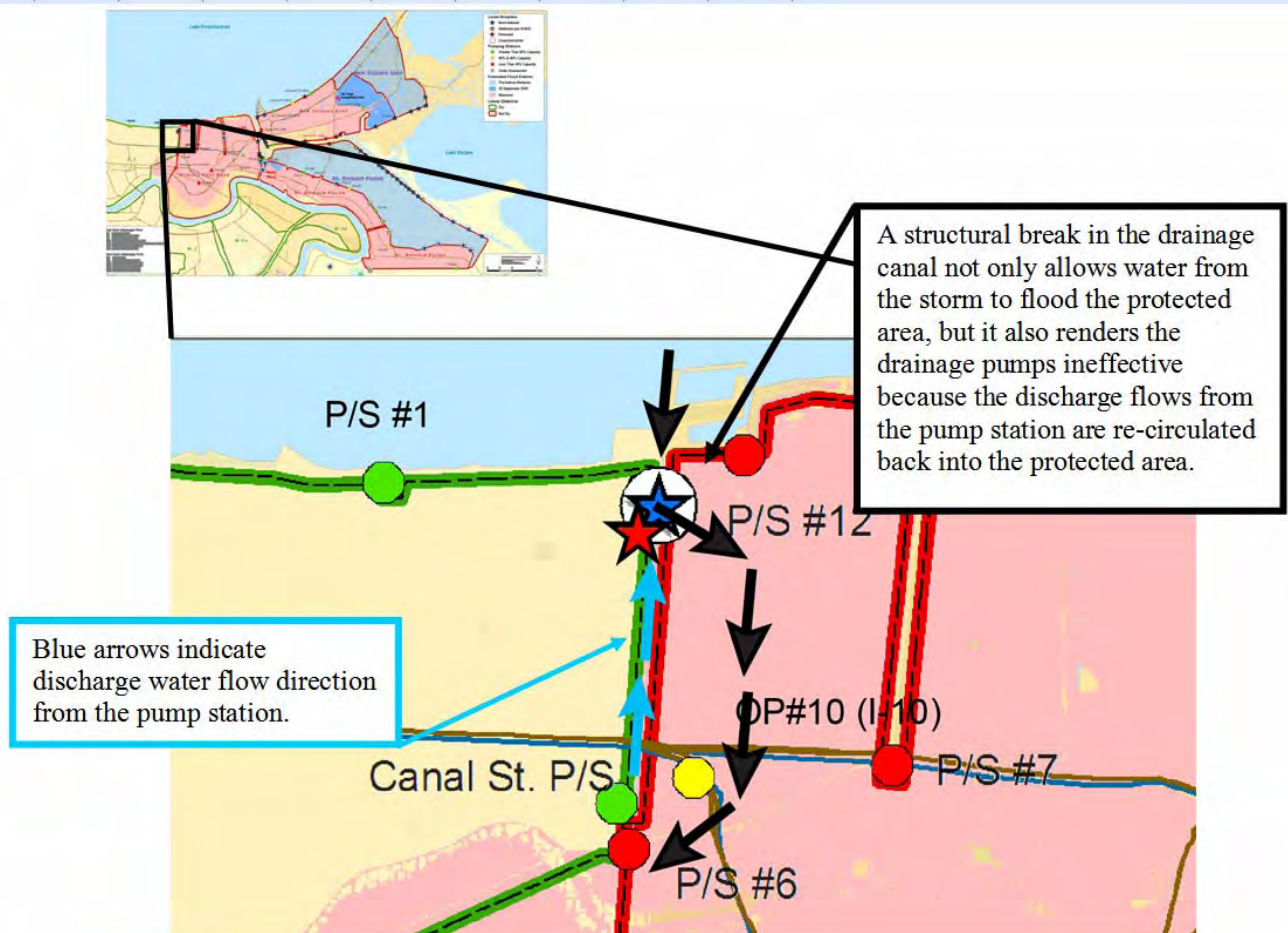
Figure 10.55: Breakdown of the pumping and drainage system as a result of structural failures within the drainage canals. Flood waters and discharge water from the pumping station flow back into the protected area where structural failures have occurred.
